Corrosion under Insulation (CUI): A review of essential knowledge and practice

R. Javaherdashti

Abstract

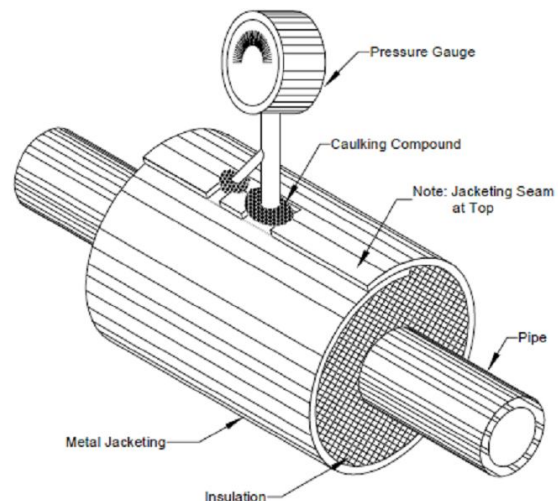
Figure 2: A schematic example of an attachment (pressure gauge) to the main body of the equipment where water bypass is possible. © National Corrosion Association (NACE)²

As it can be seen in Figure 2, the “discontinuity” dictated by the attachment lay-out on the main body of the equipment has been a significant factor in inducing CUI. In Figure 2, there is another important aspect of design that must be noted: to isolate the pipe against CUI, the design relies only on the caulking material around the gauge. The caulking compound will not be able to function properly after being exposed to moisture and/or harsh environment. A real life example of such can be seen in Figure 3 where due to water ingress, CUI has resulted in enhanced corrosion of the equipment.

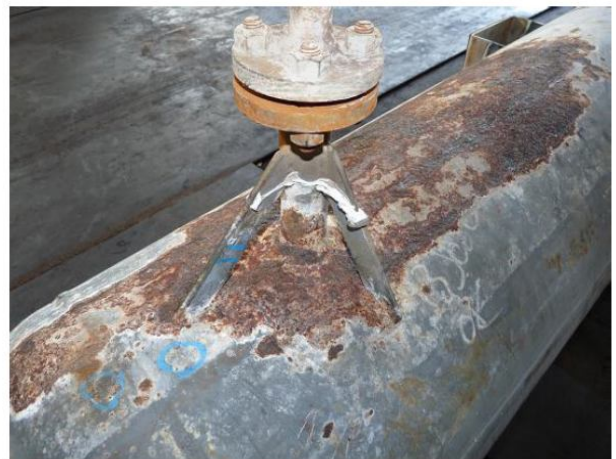
Figure 3: CUI as induced on inorganic zinc coating after working for 8 years in a coastal industrial atmosphere: Note the steam inlet nozzle and the effect of water ingress around it. © National Corrosion Association (NACE)¹⁰

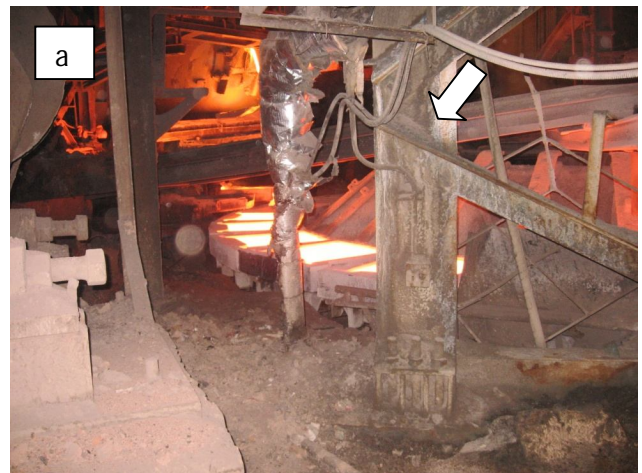
Figure 7: (a) An example of wrong application of insulation so that the wrapping is not applied completely and without openings around the equipment (b) the pipe supports can cause serious damage to the insulation material over time (Photos: Courtesy of Reza Javaherdashti).

In practice, however, it is not always the structural defects in the insulation that can give rise to water (or vapour) ingress. Misapplication of insulation (Figure 7a) is also a very important factor that can give rise to CUI.

As seen in Figure 7a, the wrapping of the insulation material has not been applied properly, leaving an open exposure to the surrounding environment. This will allow moisture to get under the insulation. When the plant is not working and thus the equipment is sitting idle, the temperature falls down and this cyclic temperature impact, also assists in creating water under the insulation through, for example, condensation. Any external factor that will cause physical damage to the insulation (such as the pressure exerted on the insulation materials –which are generally “soft” material- via pipe supports, for instance, Figure 7b can actually facilitate water (vapour) ingress.

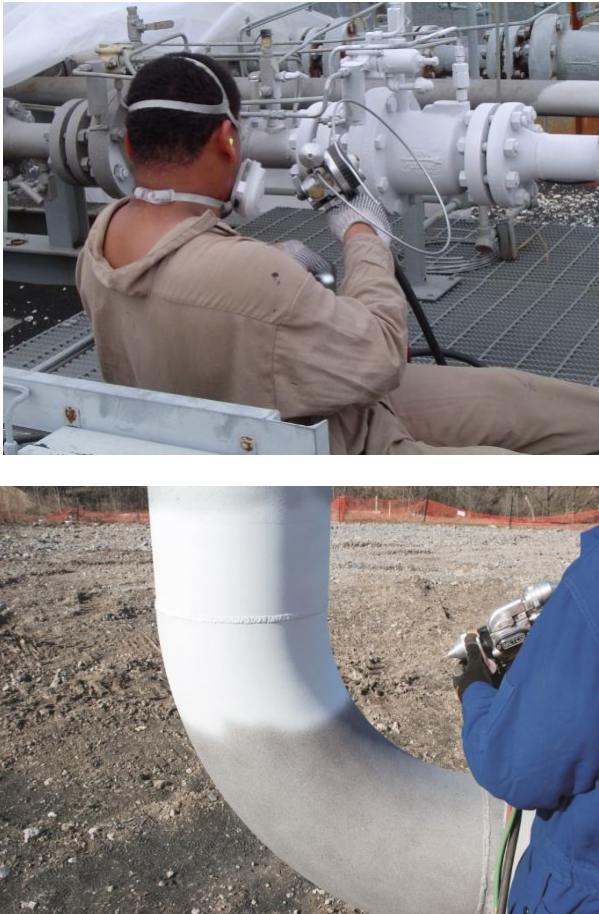
Figure 10: TSA are capable of being applied on different shapes and sizes of equipment with very good adhesion and reliability (“Copyright Sulzer Technical Review, Sulzer Management Ltd, Winterthur, Switzerland”. Used with permission)

expected. In addition to benefits such as prolonged service life, excellent applicability in various atmospheric conditions (from marine to tropical and coastal), TSA are also known for their ease of application on hard-to reach layouts of equipment and also complex shapes of equipment, Figure 10:

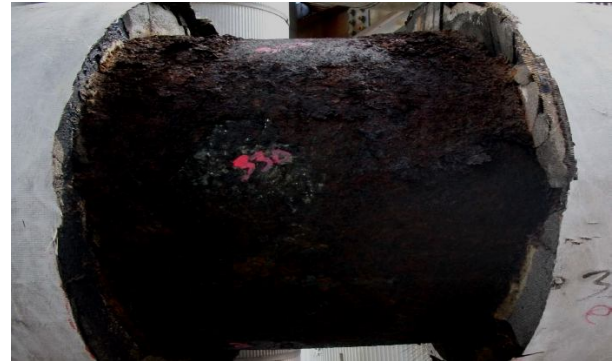
Figure 12: CUI becomes a significant issue when insulation plugs are removed but not replaced and resealed again (PetroChem Inspection Services Inc, used with permission)

- i) One of most vulnerable points to CUI in equipment will be spots where insulation plugs or ports have been removed to allow thickness measurement and not replaced/resealed again. Figure 12 shows an example of such conditions:
